[Docket No. FAA-2011-0994; Directorate Identifier 2010-NM-143-AD; Amendment 39-16949; AD 2012-03-08]

Airworthiness Directives; Bombardier, Inc. Airplanes

2012-03-08 Bombardier Inc.: Amendment 39-16949; Docket No. FAA-2011-0994; Directorate Identifier 2010-NM-143-AD.

Air Transport Association (ATA) of America Code 32: Landing gear.

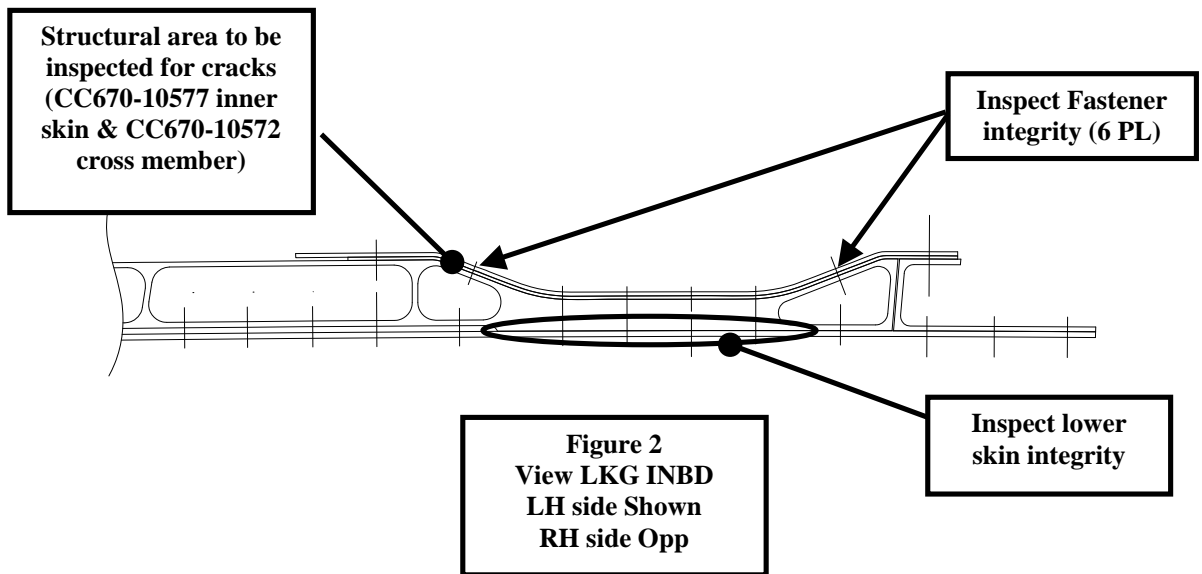
(1) Inspect the cross member, P/N CC670-10572, of the MLG door lower panel for cracking or deformation, in accordance with Figure 2 of this AD.

(2) Inspect the inner skin, P/N CC670-10577, of the MLG door lower panel at the cross member (P/N CC670-10572) for cracking or deformation, or pulled or missing fasteners, in accordance with Figure 2 of this AD.

(3) Inspect the outer skin, P/N CC670-10574, of the MLG door lower panel at the cross member (P/N CC670-10572) for cracking or deformation, or pulled or missing fasteners, in accordance with Figure 2 of this AD.

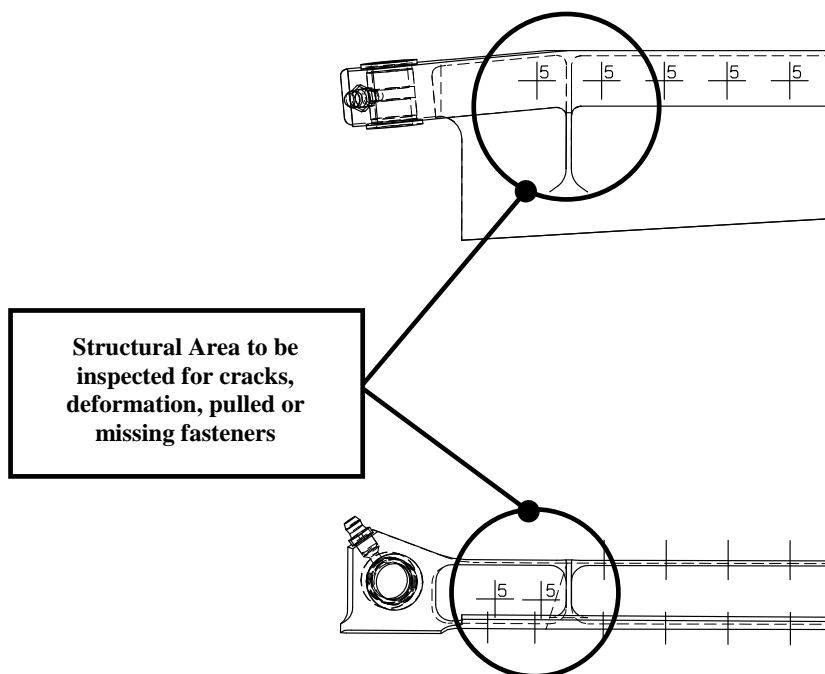
Figure 3
View LKG INBD
LH side Shown
RH side Opp

(4) Inspect the forward member, P/N CC670-10570, and aft member, P/N CC670-10571, of the MLG door lower panel for cracking or deformation, or pulled or missing fasteners, in accordance with Figure 3 of this AD. Figures 1 through 3 of this AD follow.
